DELAWARE RIVER BASIN
TRIBUTARY TO PEQUEST RIVER
WARREN COUNTY, NEW JERSEY

**ALLAMUCHY
POND DAM
NJ 00501**

**PHASE 1 INSPECTION REPORT
NATIONAL DAM SAFETY PROGRAM**

**MARCH 1980
APPROVED FOR PUBLIC RELEASE;**

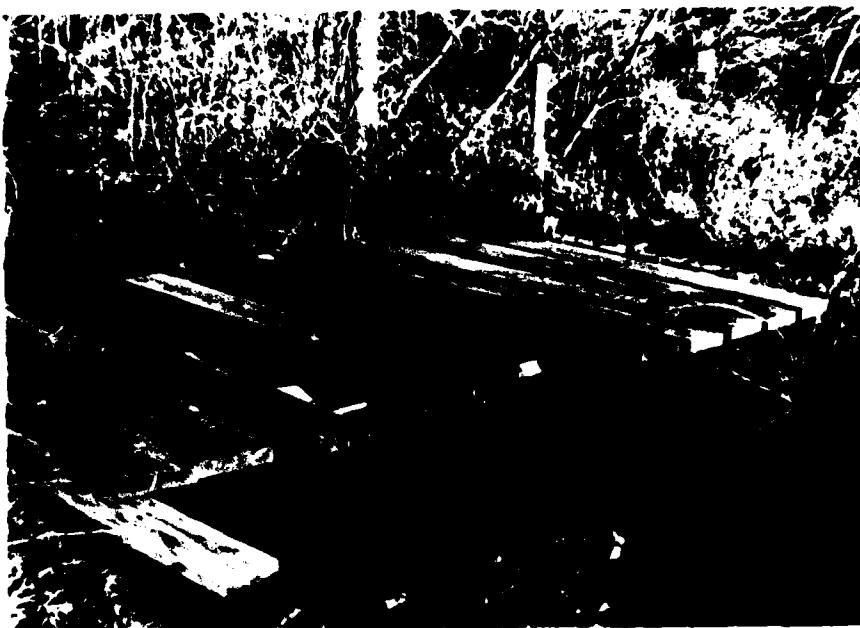
5 NOVEMBER 1979
VIEW FROM WEST EDGE OF SPILLWAY LOOKING ACROSS WOODEN FOOT-
BRIDGE, IT IS IN DISREPAIR.

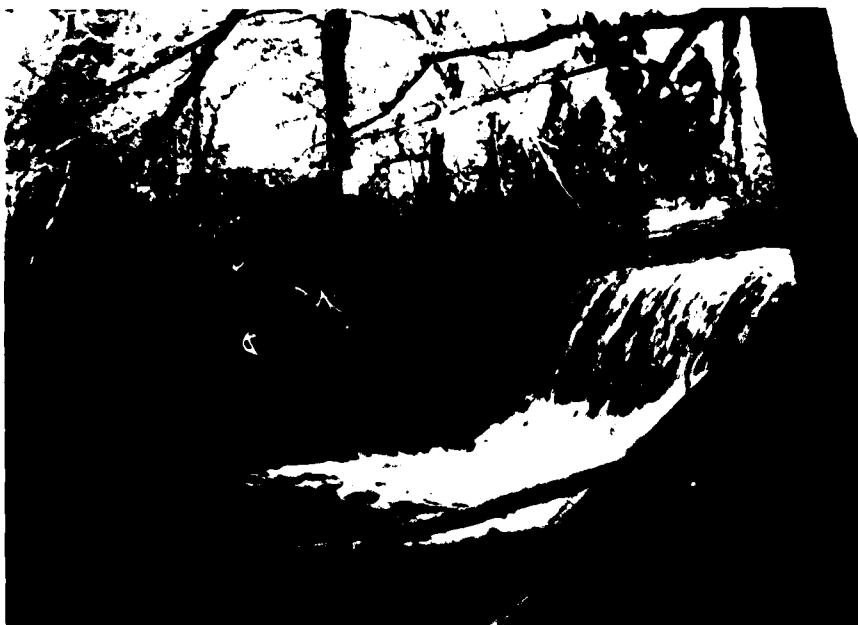
5 NOVEMBER 1979
FROM WEST EDGE OF SPILLWAY DISCHARGE CHANNEL LOOKING AT THE
DOWNSTREAM FACE OF DAM AND SPILLWAY.

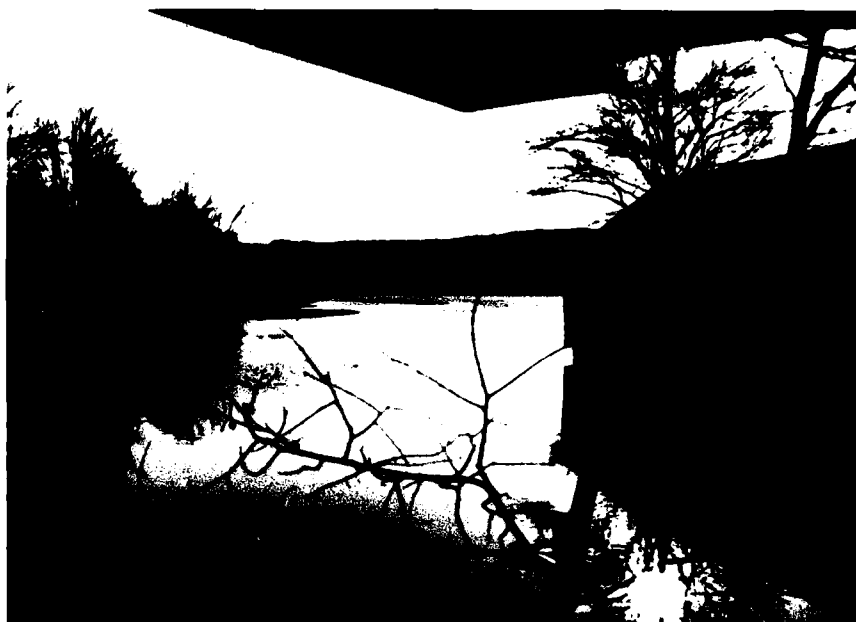
5 NOVEMBER 1979
FROM SPILLWAY CREST LOOKING UPSTREAM AT ALLAMUCHY POND.
